Arboricultural Report Findings

Location	Junction of Pedlerspool Lane & Old Tiverton Road, Sandford, Crediton		Ref:	R2532cw/AL
Client	Mid Devon District Council, Phoenix House, Tiverton, Devon		Report Date	29/10/19
Survey Inspector(s)	C Hawley Prof Dip. Arb, M. Arbor A.	A M Lane MIC For., F. Arbor A., MRICS	Inspection Date	9/10/19
Initial Report Prepared By:	C Hawley Prof Dip. Arb, M. Arbor A.	Final Report Checked & Amended By:	A M Lane MIC For., F. Arbor A., MRICS

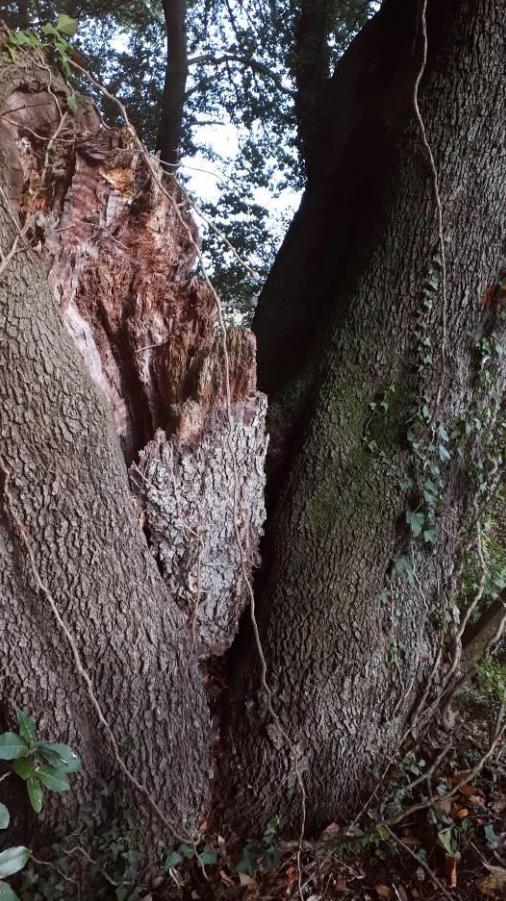
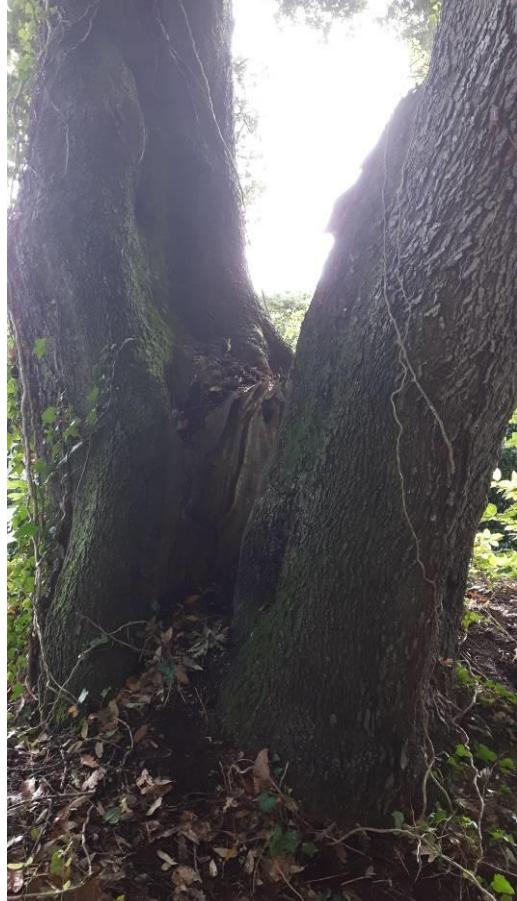
4. There is a historic wound at the base of the southern stem where an old stem appears to have failed many years ago, the decayed remnants of the old stem and its stump persist between the two remaining live stems. On the north side of the tree there is a vertical crack in the exposed wood of the old stump extending from ground level to the top of the old stump where the crack is some 2.5cm wide.

5. It appears that the crack may originate from the historic stem failure or may simply be the result of the exposed heartwood drying out and decaying over many years. There is no evidence found that the crack is actively propagating or of movement at the base of the tree.

weak embedded bark union and the union has begun to structurally fail by opening to form a crack. This is not in my opinion the case here with the two stems appearing to be growing essentially as two separate trees. There is a small area of bark to bark contact between the stems at the base on the south side (embedded bark) but they appear not to be joined above ground level by common annual rings.

4. The tree has evidently actively adapted to the described defect and the load imposed on both stems as evidenced by the observed growth ribs. Holm oak are considered to be structurally robust and are resilient to decay. There are no apparent signs of insipient failure or stem subsidence.

Plate 1: Showing the east side of the union and decayed remains of the historic third stem failure associated with the southern stem.	Plate 2: Showing the west side of the union and the oxidised remains of the historically failed stem with the observed crack.

- a. Refuse consent to part dismantle the holm oak.

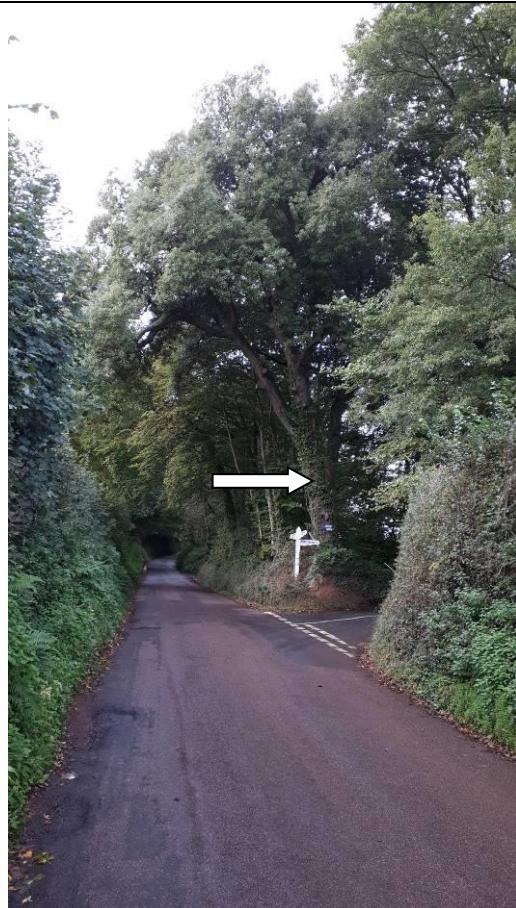
2. There are obvious short range views of the tree from Old Tiverton Road, particularly as you approach it from the north west, it can also be seen from the main Crediton to Tiverton Road, as such it adds positively to the character of the area and is seen daily by numerous people using the road. It was noted that there is a further mature holm oak located on the western corner of the copse; the holm oaks are older and more prominent than the adjacent trees and are significant features that add appreciably to local amenity.

Plate 3: Showing the subject trees from the northern approach along 'The Old Tiverton Road'. The arrow indicates the subject tree.
