Embankment badger barriers – a case study

Badger problems

The scaffold solution

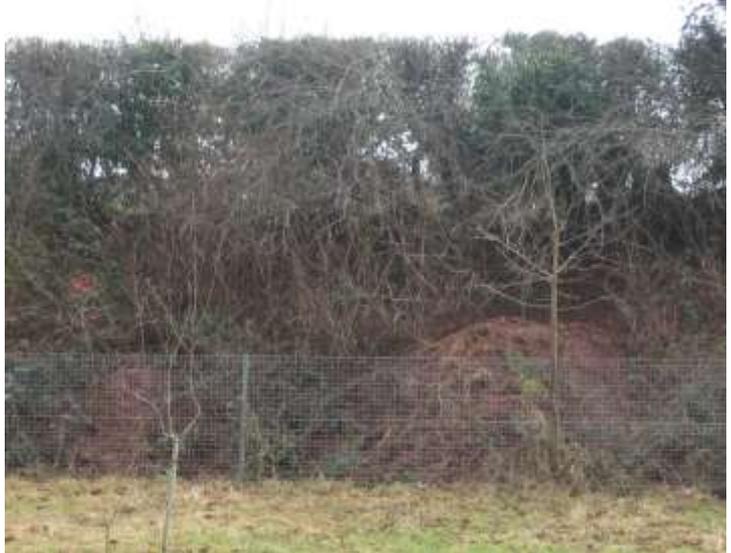
Three years ago, the Canal Ranger Service became aware that some badgers had taken up residence in a canal embankment above a primary school in Tiverton (right). DCC engineers agreed with the Canal Rangers that there was a danger of the badgers excavating through the embankment until they reached the Canal, potentially creating a leak, which could quickly erode, collapse and cause a breach, affecting the town below.

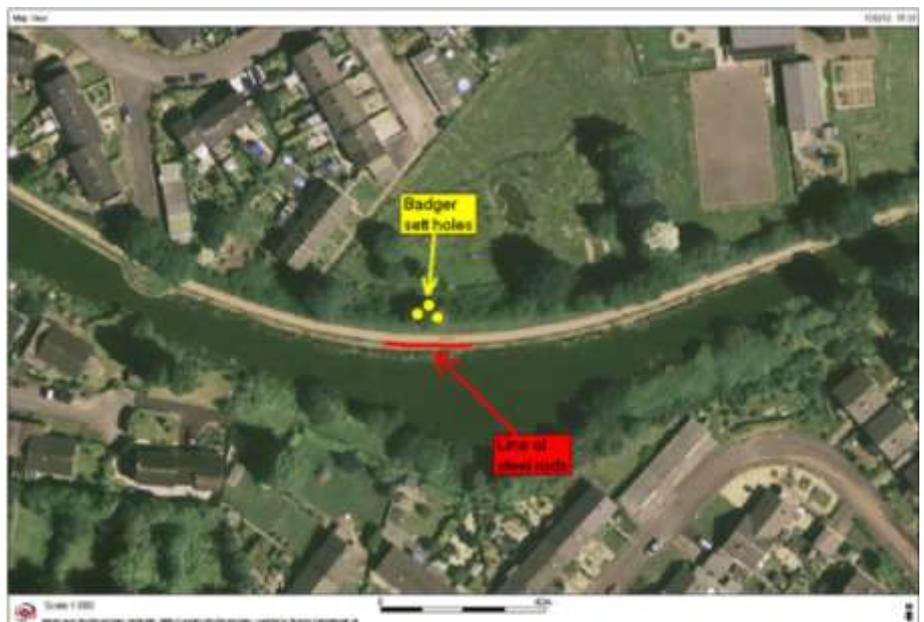
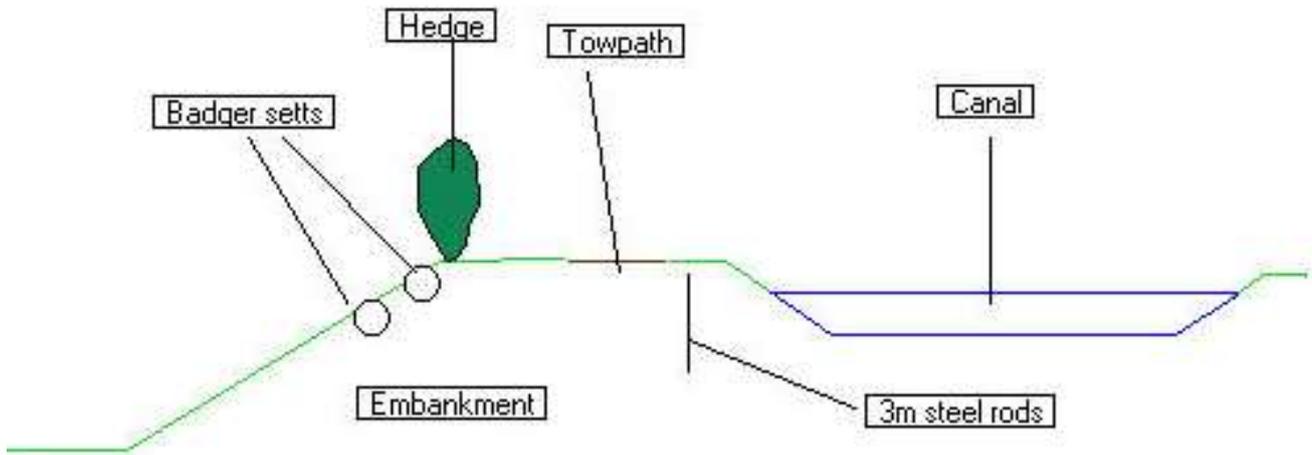
Eventually following lengthy discussions with DCC's engineers and the NE wildlife officer, a plan was devised to use scaffold poles to build a frame through which 2cm thick, 3m long steel rods would be inserted along the canal bank at a spacing of 7cm, thereby creating an impenetrable barrier to the badgers. Insertion through the 1.5m high frame would ensure that the rods remained at 7cm spacings, even at 3m below ground level. A badger licence for this work was applied for and was received in mid December 2011.

The frame was built by the Canal Ranger Service and they undertook the task of inserting the steel rods, using a hired excavator, in the week before Christmas 2011. The 2.6 tonne excavator was hired along with a hydraulic breaker ('pecker') attachment. This had been adapted for the task of pushing in the rods (rather than breaking up concrete) by having the end of the bit cut square, and a short section of scaffold pole welded on the end to provide a couple of inches of sleeve to retain the end of the rod as it was pushed down.

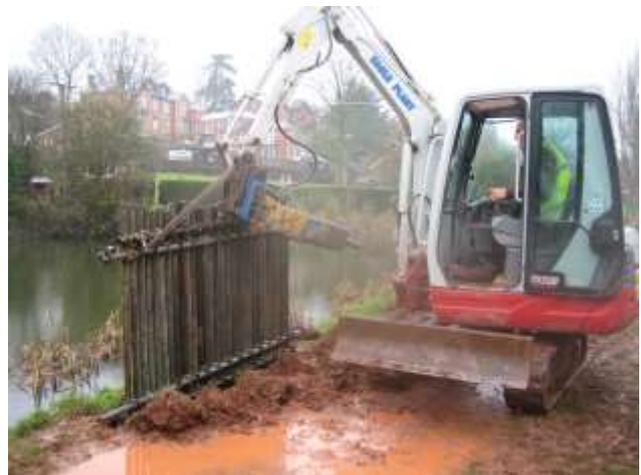
1. The frame was lifted into place by the excavator (right).
2. It was levelled and then fixed in place using a diagonal scaffold bar fixed to a post driven into the ground on the opposite side of the towpath.

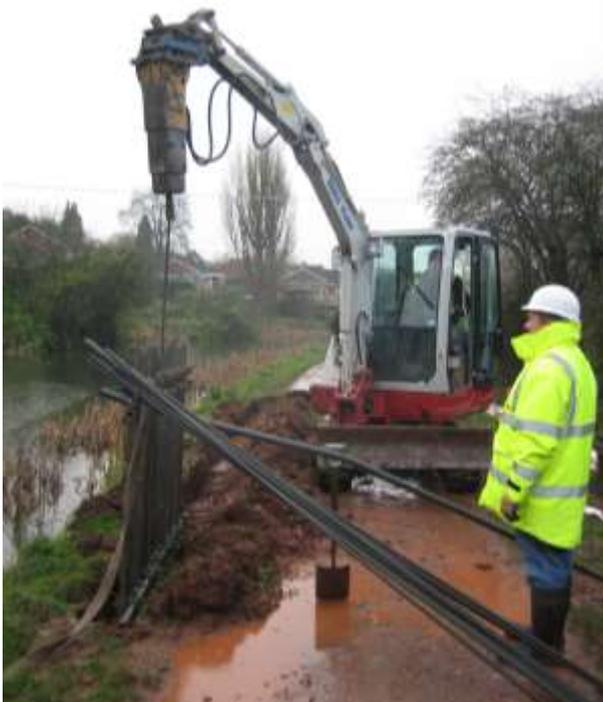
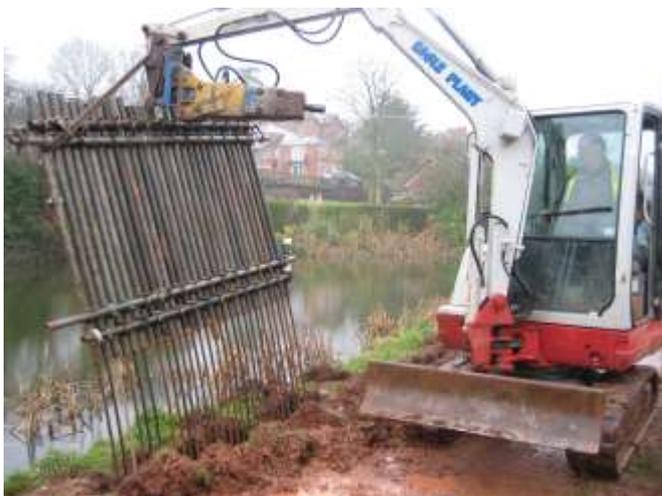
3. One by one the frame tubes were loaded with steel rods and these were pushed in by the excavator (only a few actually needed the hydraulic action of the 'pecker' to hammer them in the required depth) (left).
4. Once all of the frame tubes had been 'filled', the frame was lifted off (below left) and the excavator pushed each of the steel rods the remaining 1.5m into the ground (below right). However, in each case the end rod was left standing 1m proud so that the end tube of the frame could be fitted over it to ensure the 7cm spacing continued.

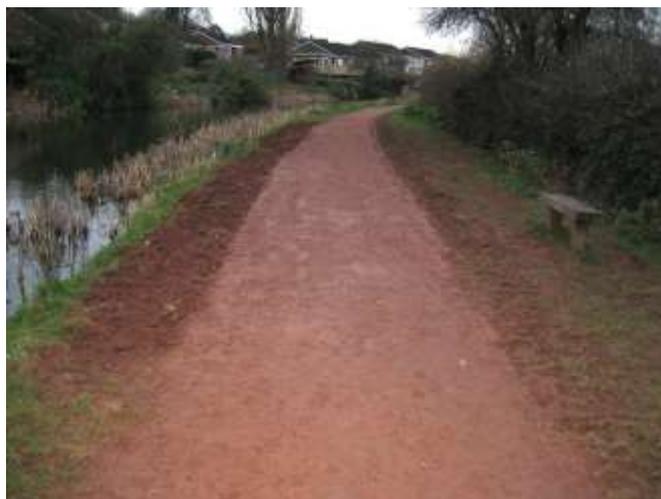
5. When all 260 steel rods were fully inserted over the 20m length, the trench was filled back in and the area was made good (right).
