Progress Report (October 2019 – February 2020 inclusive)

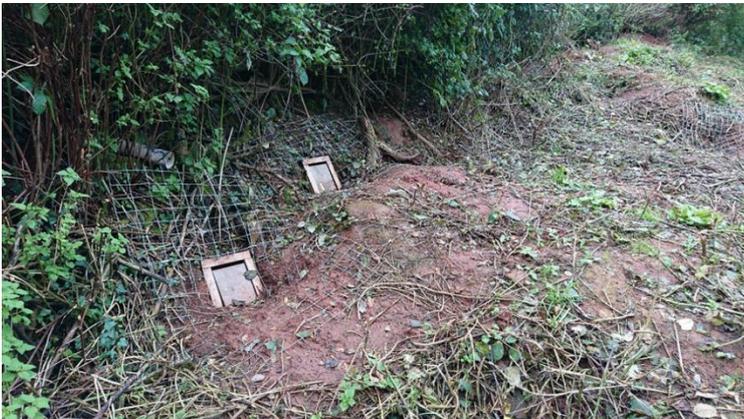
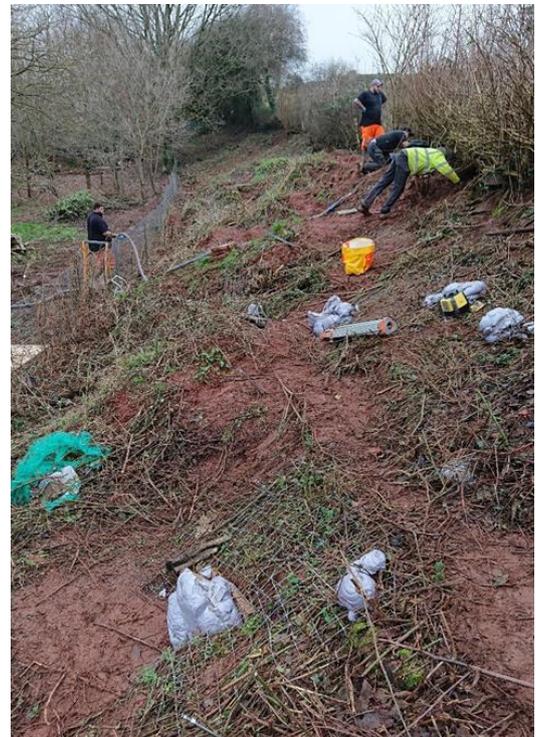
However, the badgers continued to find ways to dig back into the embankment and in the end, a fencing contractor was engaged to install a badger proof fence, complete with a buried skirt all around the entire section of embankment containing the original sett. This proved successful and the 21-day period was reached between Christmas and New Year.

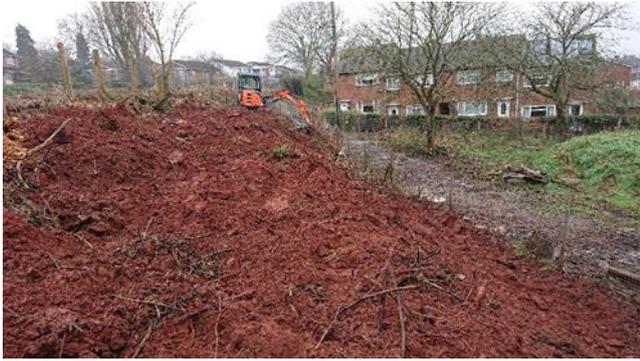
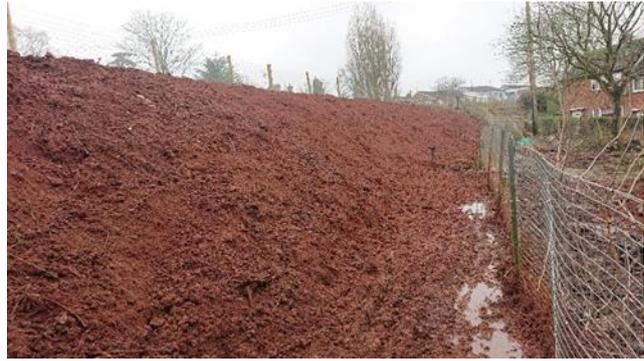
On January 7th a specialist contractor began work on filling the embankment sett tunnels with an expanding foam resin. The material was pumped in at high pressure and filled the voids, preventing reoccupation and any future subsidence.

On the 22nd and 23rd of January an excavator contractor was engaged to regrade all of the spoil heaps on the embankment.

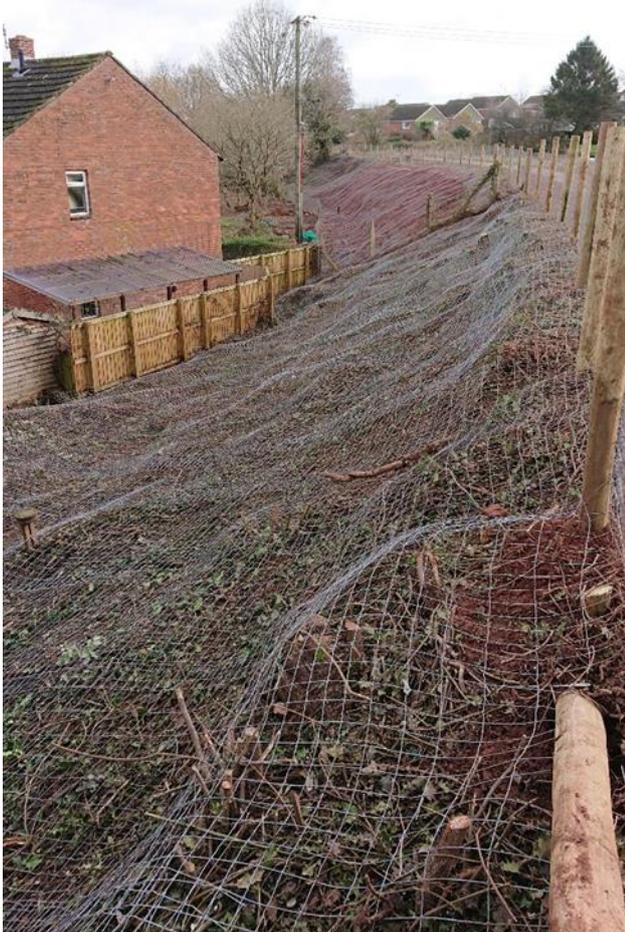
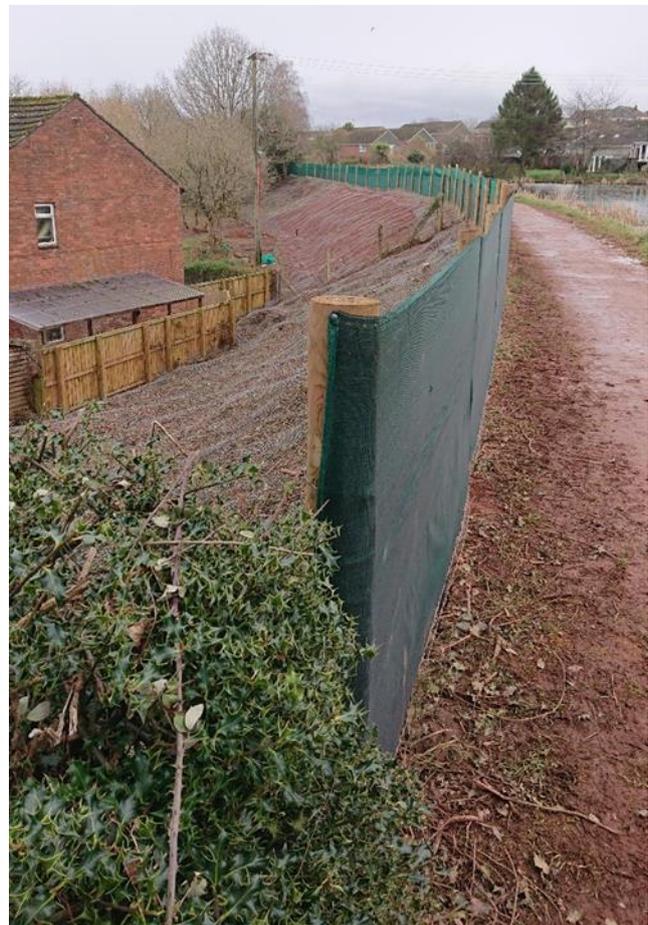
In the last week of January, a fencing contractor was engaged to cover the entire embankment with badger-proof steel netting. This is connected to the fences at the top and bottom of the embankment covering the coppiced hedge stumps, which will regrow through the mesh.

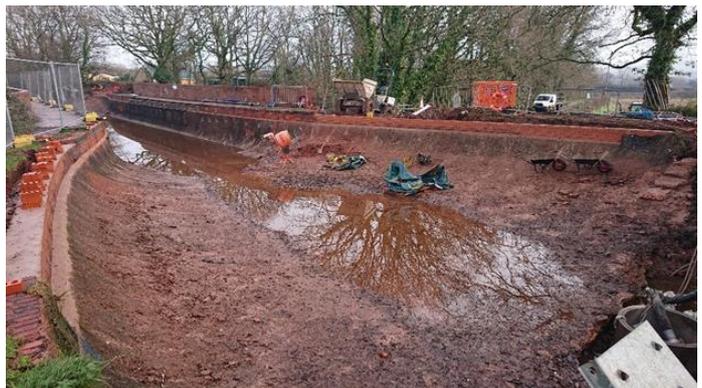
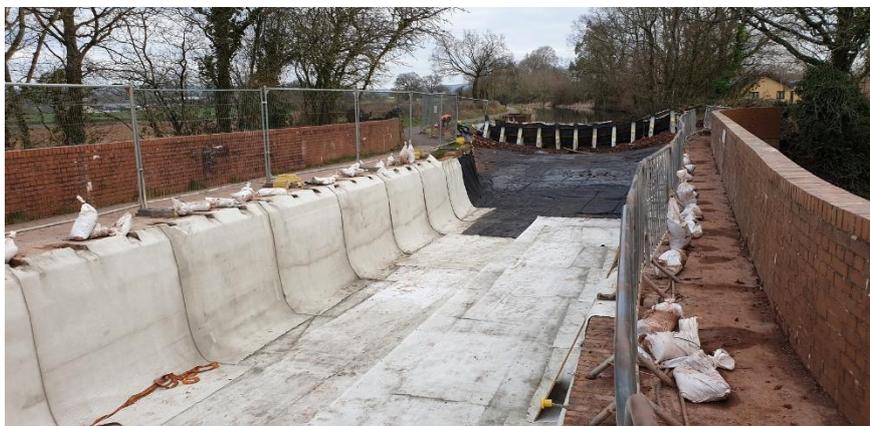
In November 2019 the canal was dammed and drained and a fish rescue was undertaken. As the aqueduct channel was cleaned out it became apparent that the brickwork on the approaches to the aqueduct was in poor condition and in need of replacement.

Most of the brickwork was replaced

before Christmas, and the dams were partially dismantled for the Christmas break to allow water to flow through thereby making it easier to manage canal water levels during the Christmas break.

The structure was re-drained in January and the installation of the liners commenced. These consisted of several protected layers enclosing a waterproof butyl liner. The final layer is concrete canvas which sets to provide a very tough protective layer.

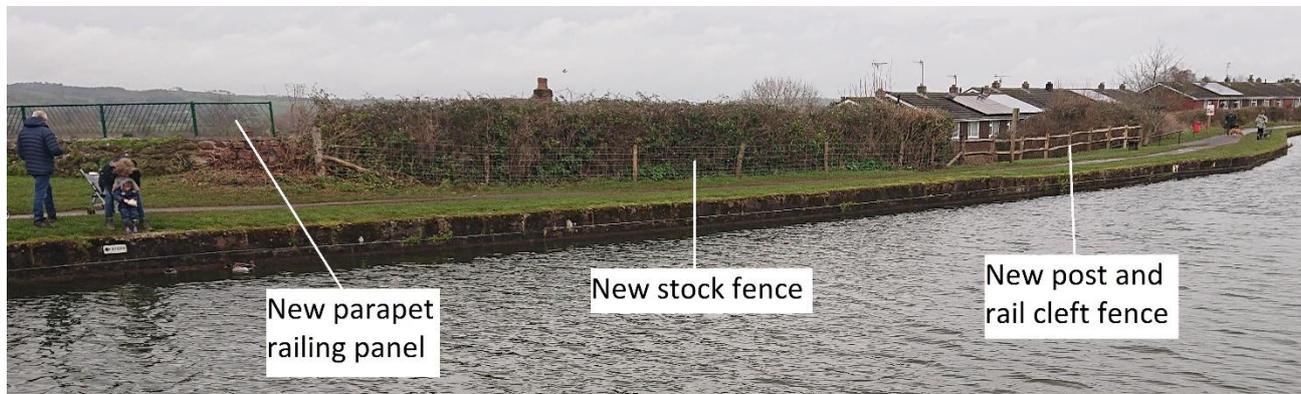
Some new fencing has been installed in the Canal Basin to improve safety. A new Sweet Chestnut post and rail cleft fence has been installed at the top of the steep slope between the towpath and the ramp beside the Canal Tea Rooms and Garden. The fencing style was chosen to compliment the adjacent thatched cottage. Following on from that towards the visitor centre a length of stock netting fence has been installed to prevent dogs or children from squeezing through gaps in the hedge at the top of the wall. The hedge will grow through the fence and hide it by the end of the summer.

In order to install this fence, some brambles and scrubby growth was cut back at the end of the parapet wall by the Visitor Centre. This revealed a gap in the parapet wall railing (most likely due to the gap being smaller than the railing panels which were installed some decades ago). A new panel has been fabricated by Morrish Engineering to fit the gap and this has recently been painted and installed.

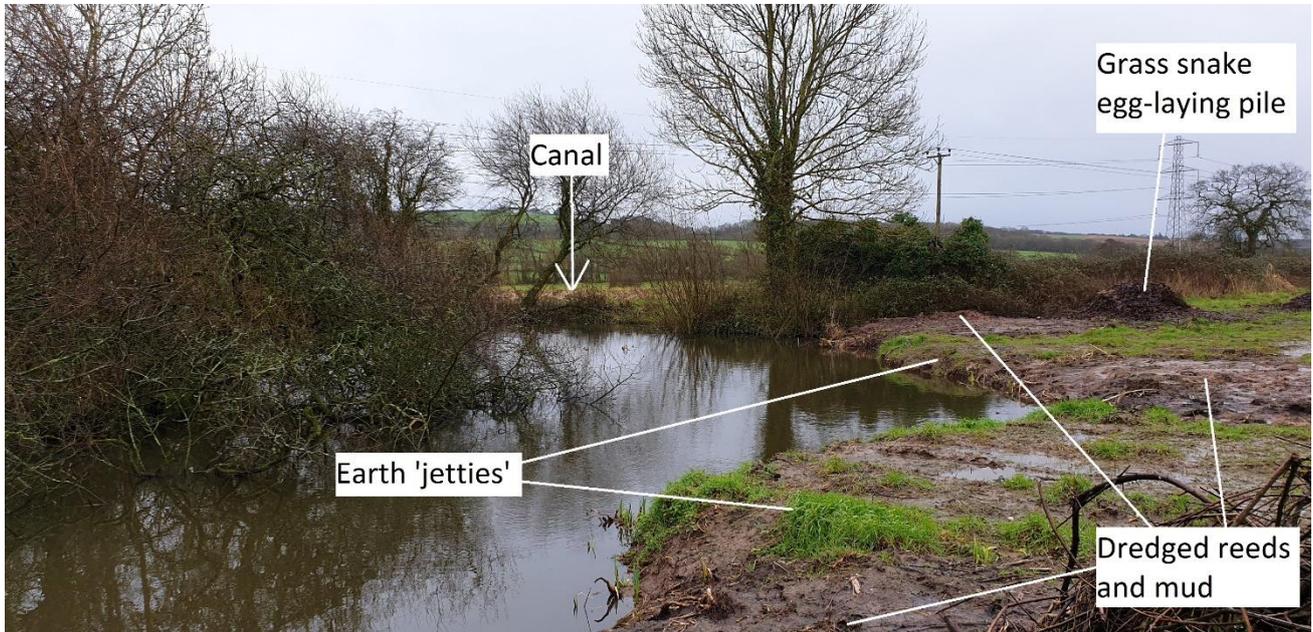
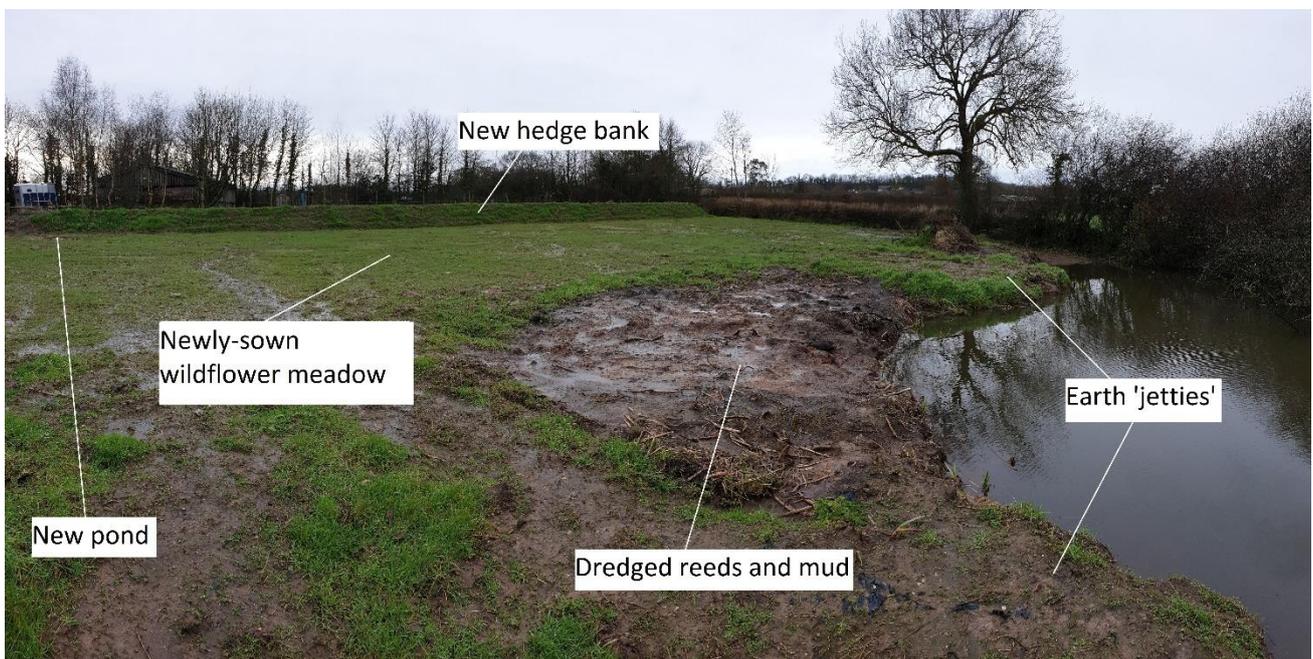
In October, an excavator contractor was engaged to dredge some of the reeds and accumulated mud from the pond and to scrape off the nutrient-rich and weed-dominated topsoil within the paddock. The scraped soil was used to make two earth 'jetties' to give the machine access to the pond, and a new hedge bank along the western side of the paddock. Another small pond was excavated beside the gateway to the paddock.

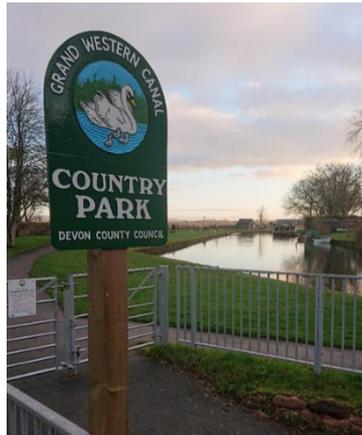
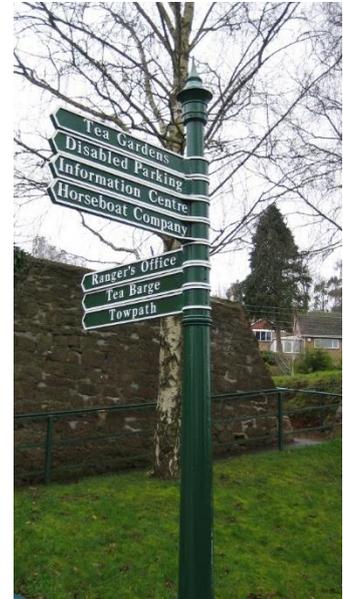
A regular wet-weather job for staff and volunteers during the winter has been the repainting of a number of the original 'cast' country park signs. These are gradually being repainted and fitted onto new posts at access points along the Canal. Most recently they have been installed at two new locations – one at the entrance from the car park to the picnic area in Sampford Peverell and one at the start of the towpath in the Canal Basin (pictured).

Rangers and volunteers are also repainting the two cast metal fingerposts in the Canal Basin car park, following the repositioning of these posts to make them less likely to be hit by cars.

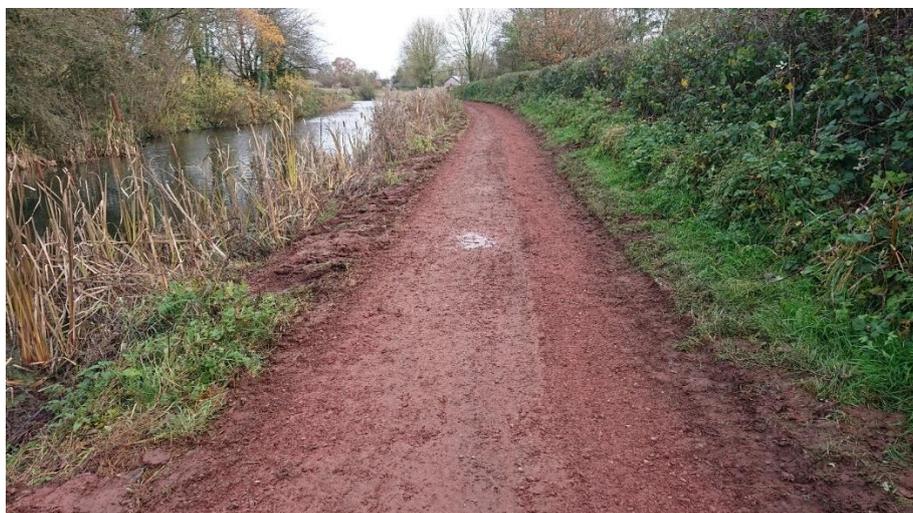
The section of towpath between Boehill Bridge and Holbrook Bridge, near Minnows Touring Park, was surfaced with compacted stone in the mid-2000s, but since then grass has slowly grown in from the edges, significantly reducing the available width of the stone surface.

In late November, an excavator contractor was engaged to carefully scrape back the grass and soil which had accumulated at the edges of the path. As can be seen from the colour difference on the photo of the path below, the available width has been doubled by this work, providing more space for towpath users to pass each other, and a firm surface for maintenance vehicles to drive on.

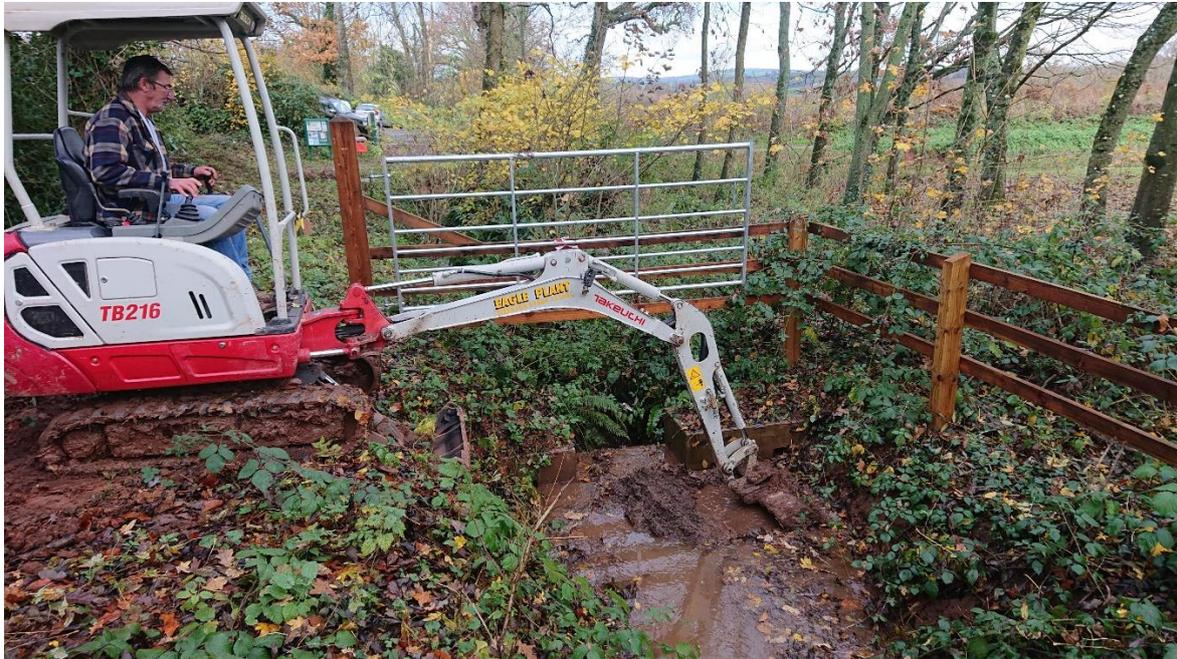
Another useful job completed by the excavator operator was the cleaning out of a silt trap that was installed earlier in the year near Manley Bridge. The silt trap captures sediment washed down from the southern end of Manley Lane before it enters the canal.

The silt trap has been emptied again in January by a wheeled digger which was able to expand the size of the silt trap and increase its capacity.

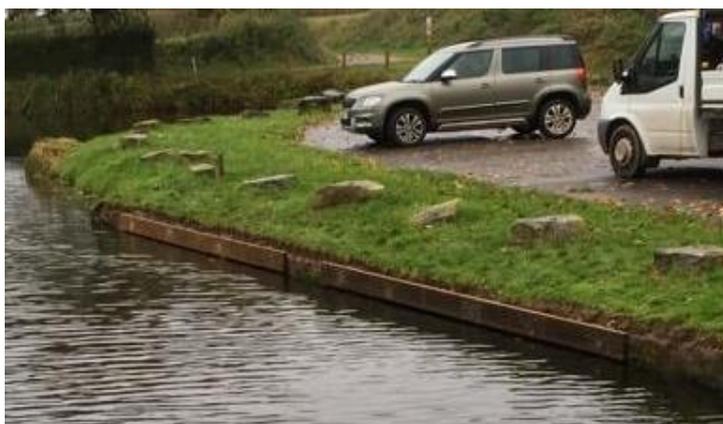
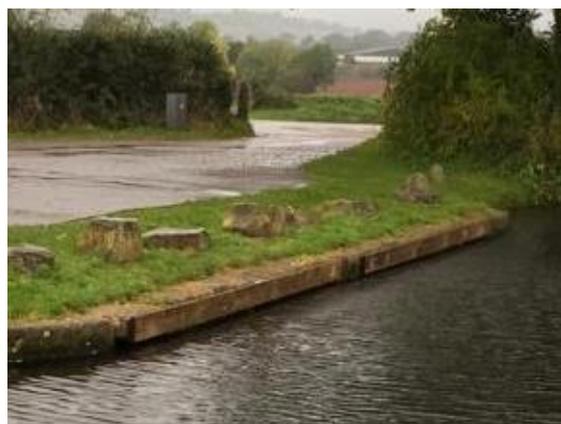
In response to a request from Mid Devon Moorings on behalf of boaters, four timber fender planks have been bolted to the wharf wall at Tiverton Road car park, to protect boats from scraping their hulls on the wall as they moor before and after passing through the Dudley Weatherley Jubilee lift bridge.
