Damp & Mould Review 2023

November 2023

Rosie Wills, Technical Support & Repairs Manager, MDH

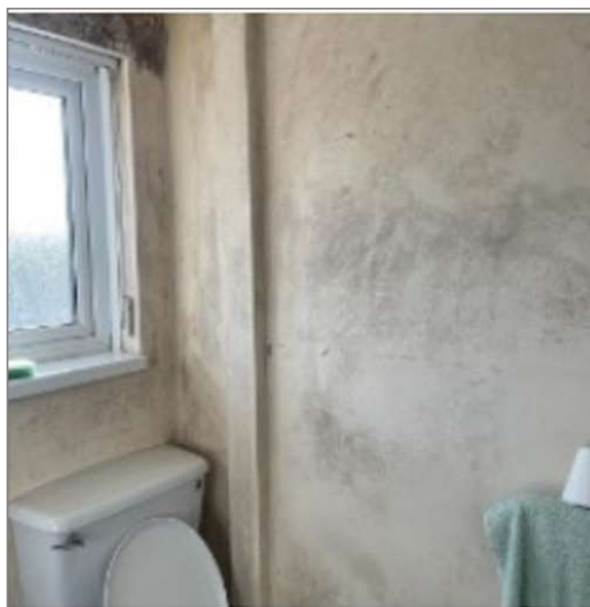
- 9.10. Mould growth will generally form in patterns consistent with thermal bridges, such as those seen in the image on the left. Note the classic crescent shape, as well as the mark on the carpet indicating the presence of furniture close to this wall in a corresponding area. This is what we would expect to see in untreated mould, and in mould previously treated with fungicidal treatment. The photo on the right shows one thermal bridge around the concrete lintel, however the mould is evenly and widely spread over all wall surfaces, including the surface of boxing. There are visible wipe marks. This is indicative of a room which has been ‘treated’ at least once with a bleach solution. Anecdotally, this will bleach the spores, but not kill them, and spreads the spores further around the room during each ‘treatment’. It also seems to feed the mould and worsen the symptoms in general. This is supported by scientific reports.

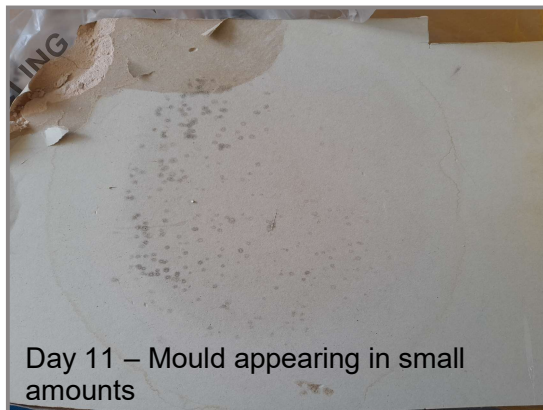
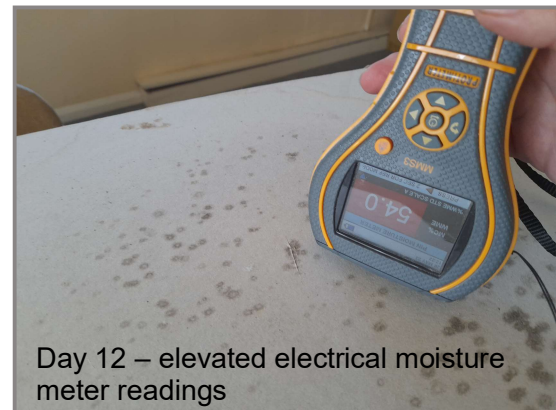
9.18. Photos

- 9.11. We carried out a rudimentary experiment in our repairs depot which involved creating an artificial version of the conditions we see in some of our homes, to see what could be learned. A sheet of dry plasterboard was placed in an environment with no direct contact with water, but periods of high humidity. The humidity fluctuated from 50% most of the time, to above 70% RHI for periods of around 2 hours per day. This is consistent with, or less humid than many of the environments we see during regular mould inspections. The temperature of the plasterboard and air remained relatively consistent, at around 21°C. Black spot mould began to form within 12 days.

- 9.12. Despite starting as a dry section of board, measuring 7.5% wood moisture equivalent (WME), by day 12, the first 1-2mm of board had become damp, with readings of 54% WME. By day 18, this had increased to 61%WME. This is despite never having been in direct contact with a water source other than air borne.

- 9.17. Sections of the other side of the board were treated with bleach, Dettol mould and mildew spray, a two part Dry-Zone treatment and an anti-bacterial spray.

9.19. A number of factors influenced the experiment, leading to conditions differing to that which we might find in our homes. We will likely repeat the experiment with greater controls to support better learning, and also include Bactdet/Halophen. What the experiment did suggest it is that:

- Widespread and extreme mould can form in the absence of any structural defect or cold bridge if humidity levels are sufficiently high.
- Surface condensation can lead to wetting of a building material, measurable with an electrical moisture meter (more than 60% WME or 999 REL), which in the home environment could be misdiagnosed as rising, traumatic or penetrating dampness.

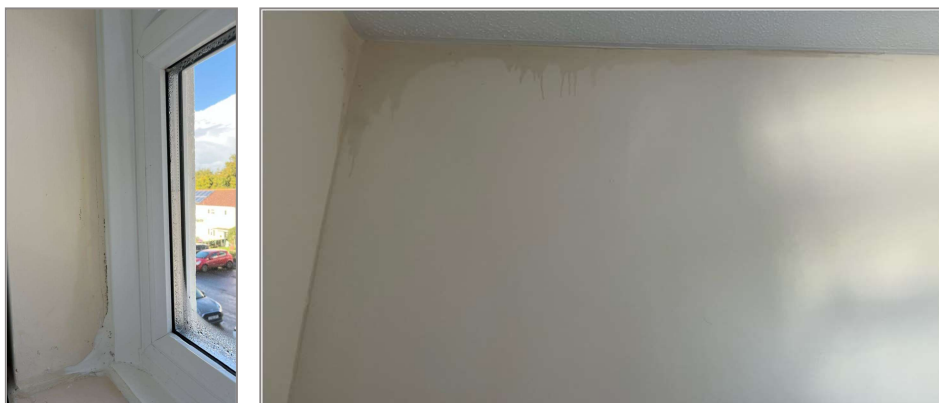
- 11.5. In a similar scenario, in Winter 2022 MDH were contacted by a tenant who was experiencing symptoms described as ‘water pouring from the ceiling’ and ‘leaking windows’. Further questioning highlighted that there had been no recent rain, and the windows were very newly installed.
- 11.6. Whilst arrangements were made to check for any issues in the roof and to check the fit of the new windows, the tenants were advised about the possibility of the cause of moisture relating to

- 11.7. The checks confirmed that there was no roof or window leak, and that the loft was evenly insulated. The combination of the draught proofing of the new windows and the cost-of-living crisis appears to have been the cause of this quite severe presentation of dampness.

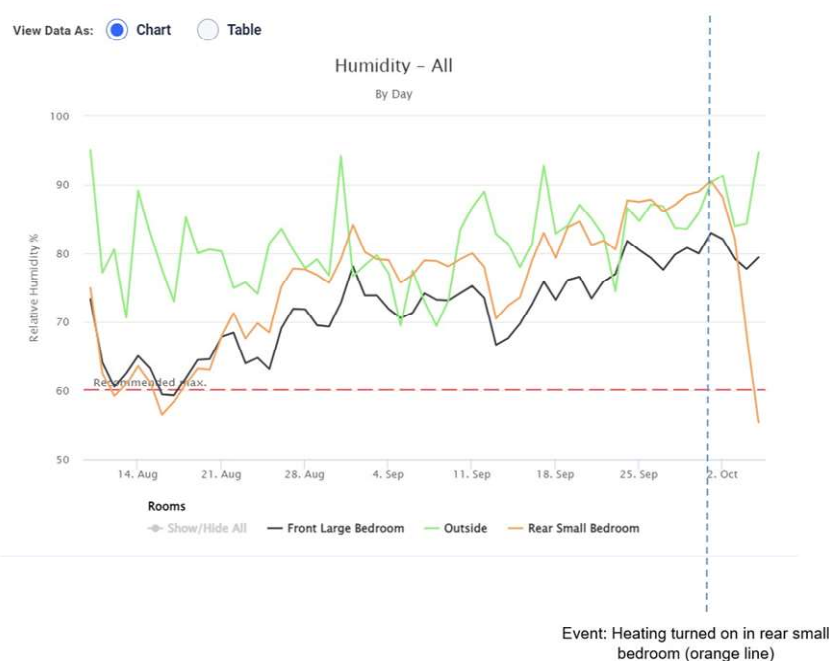
13.5.

- 13.3. During the week commencing 2 October 2023, however, we had breakthroughs with two properties which were being closely monitored.
- 13.4. Property A had been assessed several times and no structural defect had been identified. A PIV had been fitted, but some overcrowding (5 people in a 2-bedroom bungalow) was likely to be significantly impacting on humidity levels and mould affecting furniture and soft furnishings. We were in regular touch with the tenants and had suggested some trial and error, to experiment with balancing heating, moisture production and ventilation. A massive reduction in humidity down to a healthy level was noticed. Communication with the tenant confirmed that this corresponded with heating being turned on in the room.
